# Studying the Reasons behind the Occurrence of Cracks in the Bucket Elevator in the Lebda Cement Factory

## Abstract

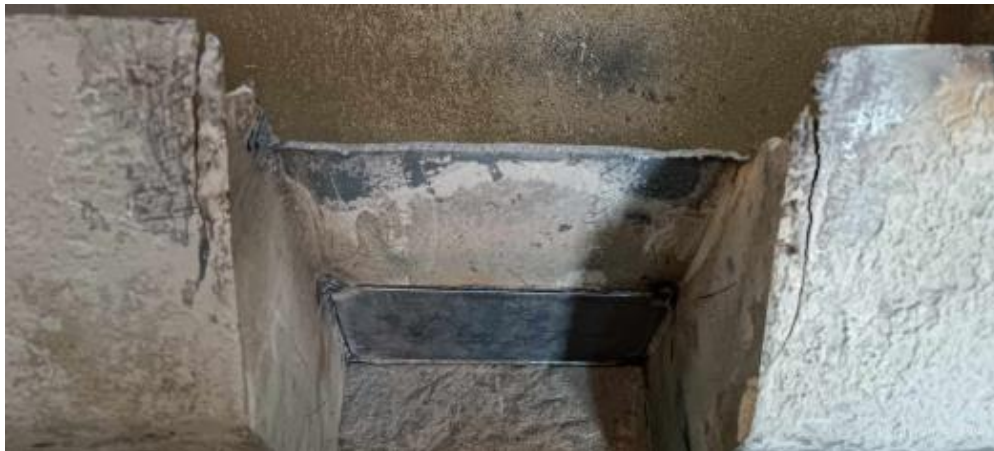
This study aims to identify the reasons behind cracks that occur in buckets at the Lebda Cement Factory [11], and Figure (2) shows a bucket with cracks.

Figure (2): a bucket with cracks.

In this study, a series of tests were conducted on samples of the bucket's metal in order to investigate the underlying cause of cracks occurring at the edges of the cement transport bucket. Various tests were carried out, including chemical analysis, tensile strength testing, hardness testing, and metallurgical analysis. The results of these tests were then compared to the standard specifications for the S235JR steel, which the bucket was made of. Chemical analyses showed that the percentage of carbon and Si are below the required standards. However, the tensile strength, elongation, and hardness were found to be within the recommended range, but the yield strength value is higher than the specified value and exceeds it by more than 100 N/mm<sup>2</sup>. The metallurgical analysis indicated an irregular distribution of the grain boundaries with, the accumulation of cementite in several areas, indicating that the metal has not been properly heat treated, which may contributed to the cracks occurring at the edges of the cement transport bucket.

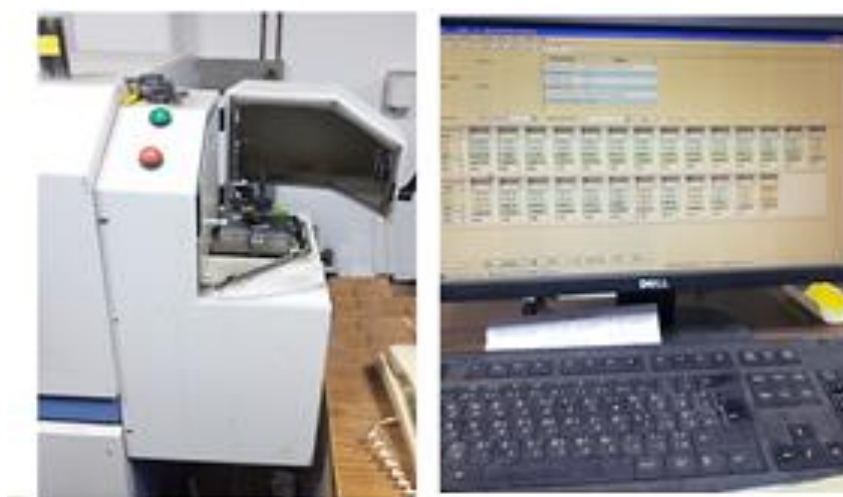
The chemical analysis of the bucket metal was carried out in the Misurata Iron and Steel Factory laboratories using an optical emission spectrometer (ARL 3460-OES-METALS ANALYZER), and Figure (3) shows the optical emission spectrometer.

Figure (3): The optical emission spectrometer

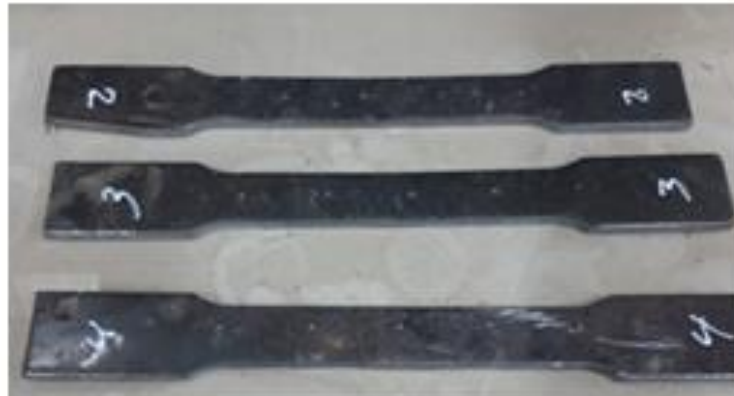
The samples were prepared according to (ASTM E8-81) and tested at the Misurata Iron and Steel Factory [15]. The average tensile test results are presented in Table (5).

Figures (4) and (5) display, respectively, the samples prepared for tensile testing and the tensile testing machine used to examine the tensile specimens for this study.

Figure (4): Samples for the Tensile Test

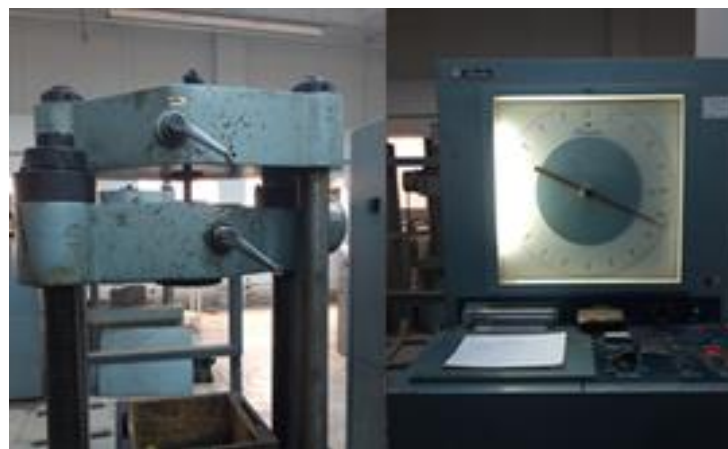
Figure (5): Tensile test machine
